Sloan Flushometer

Manual Flushometers

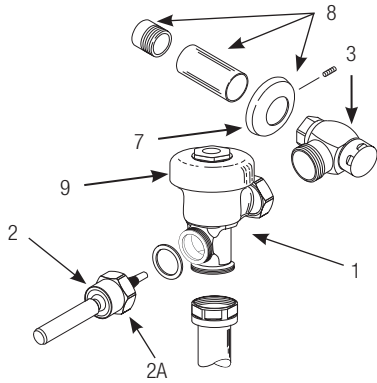
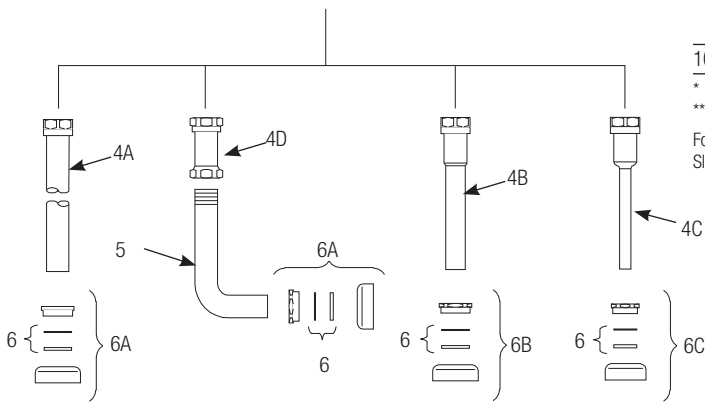
PARTS LIST

Item No.	Code No.	Part No.	Description
1.	—	A-3-A	Valve Assembly – contact Tech Support for proper assembly
2.	0302390	B-73-A	ADA Compliant Handle Assembly
2A.	0301082	A-6	CP Handle Coupling

3.	—	H-710-A	Bak-Chek® Control Stop – 3/4" or 1"
4A.	5323007	V-500-AA	1-1/2" (38 mm) x 9" (229 mm) Vacuum Breaker Assembly ** – 6 per package
4B.	5323006	V-500-AA	1-1/4" (32 mm) x 9" (229 mm) Vacuum Breaker Assembly – 6 per package
4C.	5323005	V-500-AA	3/4" (19 mm) x 9" (229 mm) Vacuum Breaker Assembly – 6 per package
4D.	—	V-500-A	Vacuum Breaker Assembly

5.	0396293	F-109	1-1/2" (38 mm) Elbow Flush Connection
6.	SEE SLIP JOINT GASKETS AND RINGS TABLE BELOW		
6A.	0306145	F-56-A	1-1/2" (38 mm) Spud Coupling Assembly
6B.	0306142	F-55-A	1-1/4" (32 mm) Spud Coupling Assembly
6C.	0306102	F-54-A	3/4" (19 mm) Spud Coupling Assembly

7.	—	F-7	Supply Flange (Supplied when Valve is not Ordered with Sweat Solder Kit)
8.	3308782	H-633-AA	1" (25 mm) Sweat Solder Kit with Cast Set Screw Flange
	3308788	H-636-AA	3/4" (19 mm) Sweat Solder Kit with Cast Set Screw Flange

9.	0378000PKSV-10		CP Sloan Cover
	0378003PKSV-10-HE		CP High Efficiency Sloan Cover
10.	3388015	H-1015	Flow Control Kit (not Shown)(HEU Only)

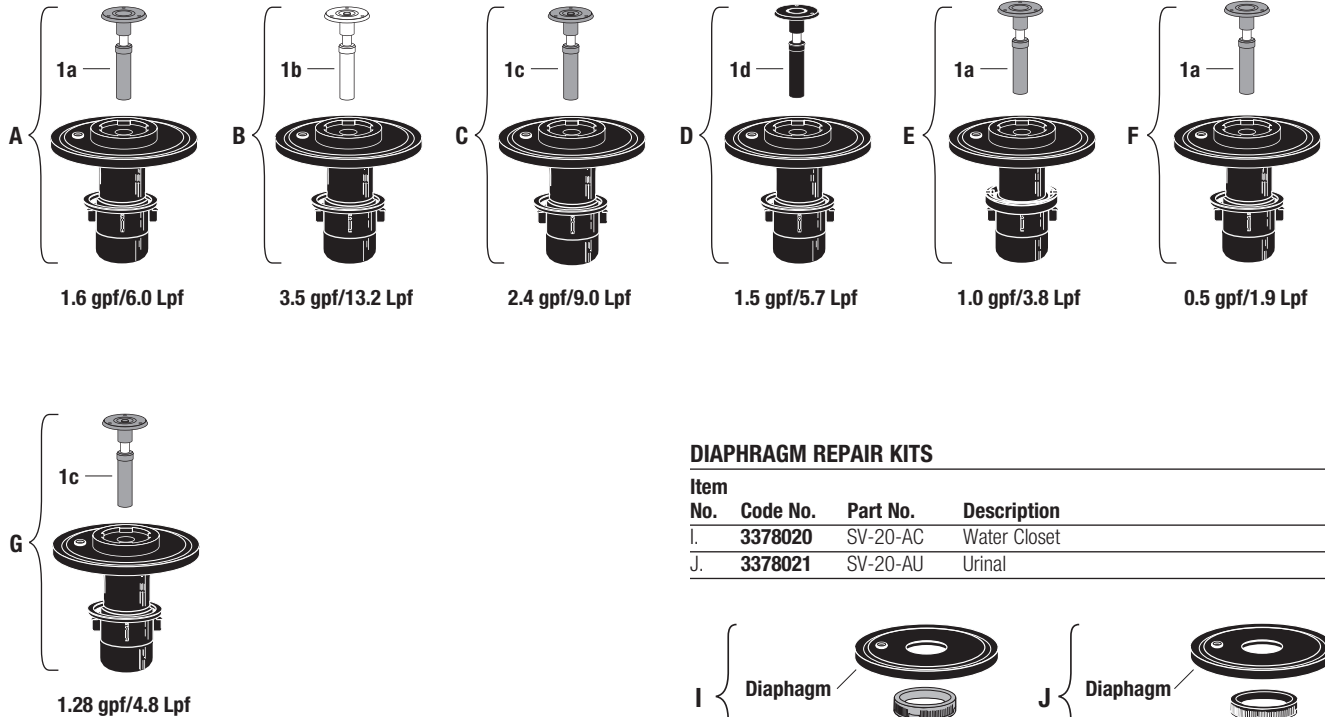
INSIDE COMPONENTS

Item No.	Code No.	Part No.	Description
1a.	5301211	A-19-ALC	Relief Valve, Green (Closet/Urinal-LC) – 12 per package
1b.	5301058	A-19-AC	Relief Valve, White (Closet) – 12 per package
1c.	0301143	A-19-AL	Relief Valve, Blue (9 Liter Closet)
1d.	5301059	A-19-AU	Relief Valve, Black (Urinal) – 12 per package

DIAPHRAGM REPAIR KITS

Item No.	Code No.	Part No.	Description
I.	3378020	SV-20-AC	Water Closet
J.	3378021	SV-20-AU	Urinal
